**A demonstration of the efficacy of the Handle Hygiene system with contamination on door handles in a major Irish Hospital.**

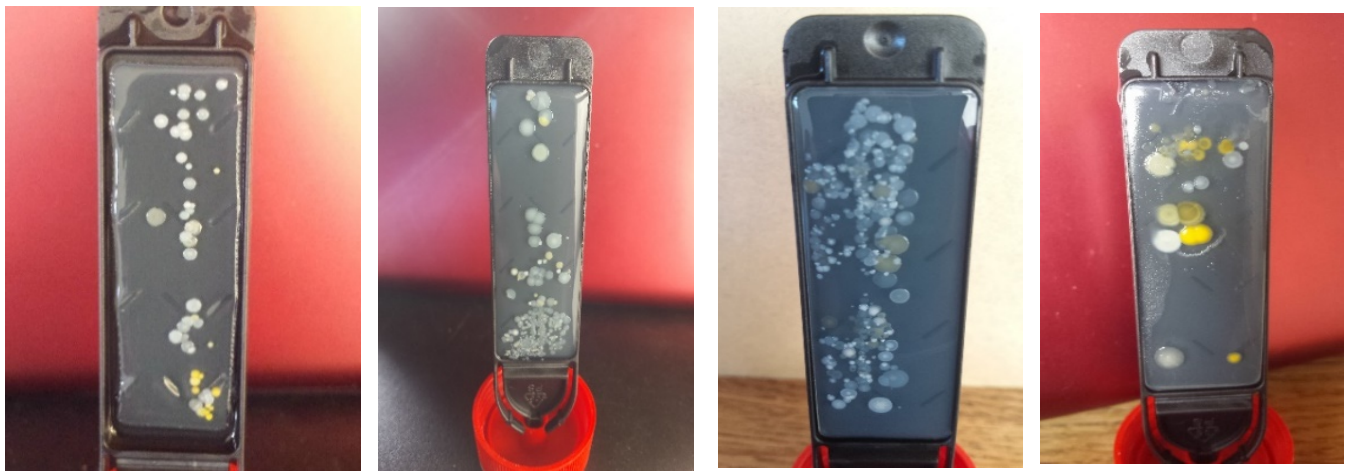
Swabs from door handles in an Irish hospital, showing a high number of bacterial colonies, typical of those found on shared or common-use washroom door handles.

They display a wide range of species, including those typical of Staphylococcal, Klebsiella and a number of other opportunistic species and pathogenic species any of which pose a risk in a healthcare environment.

Hygicult Contact slides showing the Cfu count on the handles **Pre-installation**.

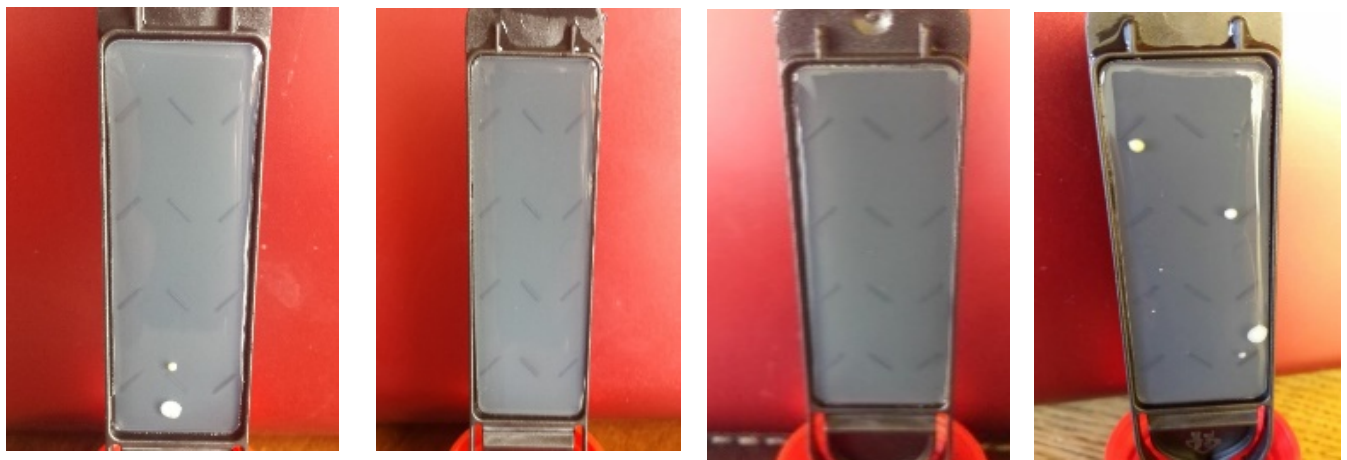
Following the installation of the Handle Hygiene system, the Cfu's count on the door handles is reduced significantly.

Hygicult Contact Slides showing the Cfu count on the handles **Post-installation**

The system secures a positive reduction in contamination levels on the handles by coating them with disinfectant each time the door is used, reducing any risk of cross contamination to a negligible level.
